HOME INSPECTION REPORT

Your Home

Sunday, July 28, 2019

9134

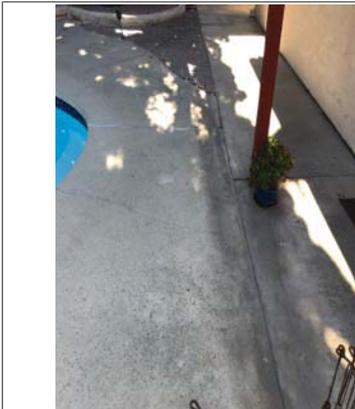
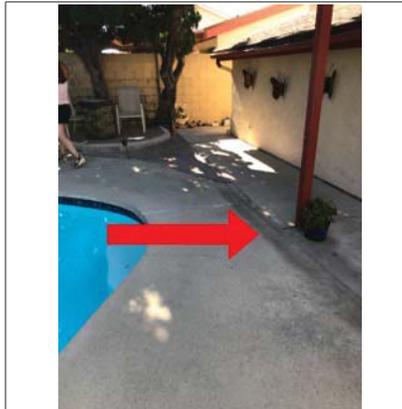
- None
Material Concrete Flagstone Kool-Deck Brick Other: _____
Condition Satisfactory Marginal Poor Settling cracks Trip hazard
 Pitched towards home (see remarks) Drainage provided Typical cracks
Comments Deck around pool not sloped to drain. Recommend a channel drain installed to keep water from puddling see picture
Photos

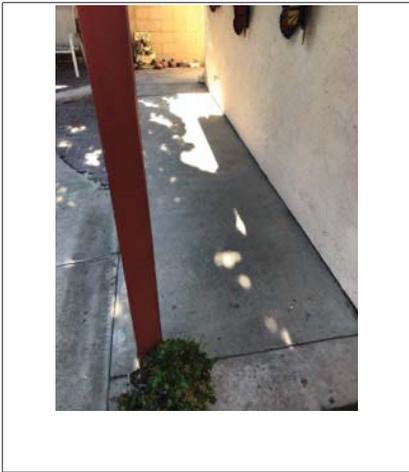
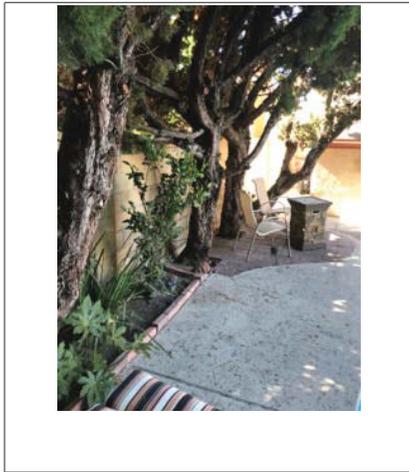
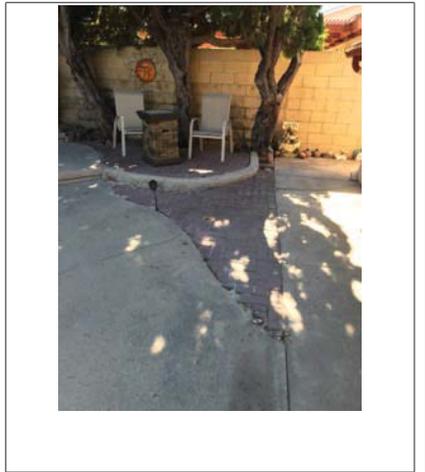
Water has no where to go, slopes away from both pool and house

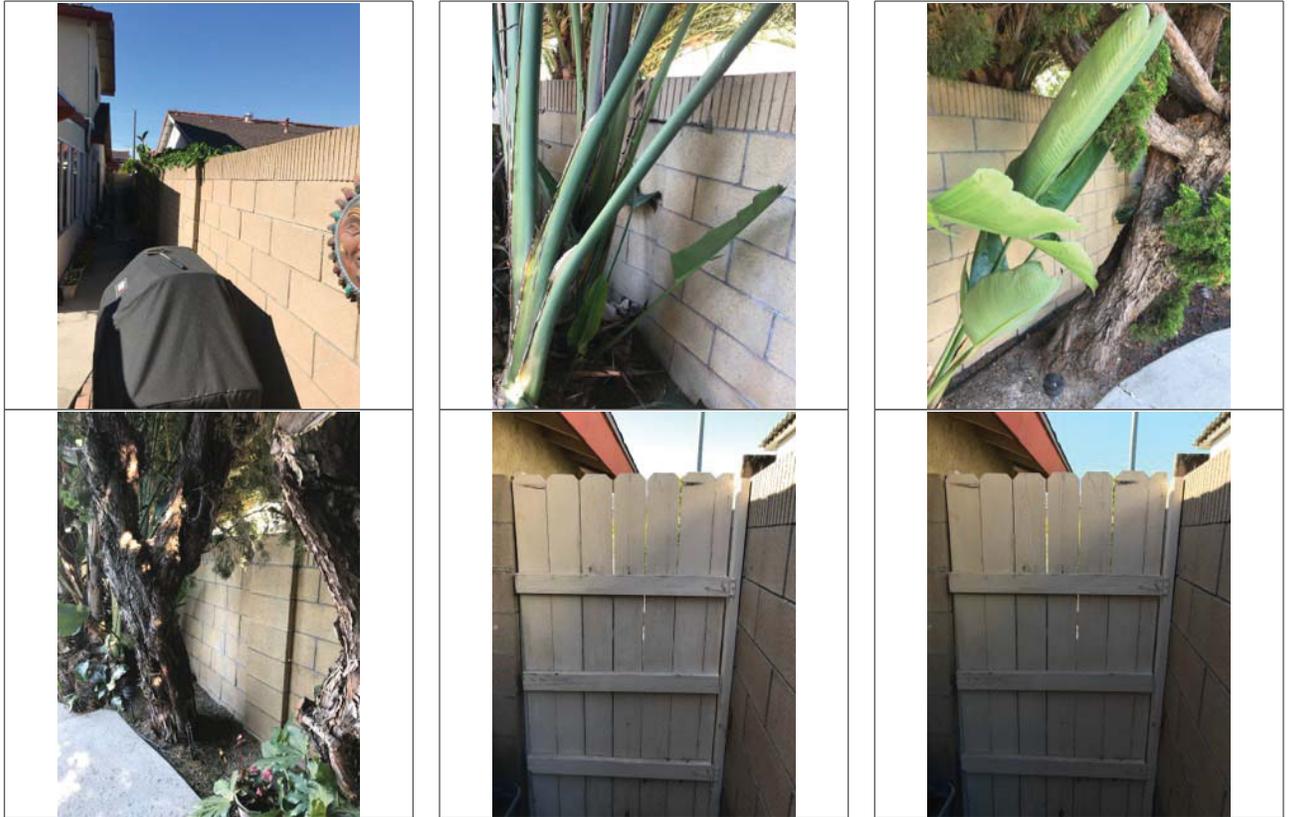
- Not evaluated None
- Type** Brick Block Wood Metal Chain Link Rusted Vinyl
- Condition** Satisfactory Marginal Poor Typical cracks Loose Blocks/Caps
- Gate** N/A Satisfactory Marginal Poor Planks missing/damaged Operable: Yes No
- Comments** Backyard rear block wall out of plumb. Leaning back and cracking

Gate to enter the backyard Needs to have self closing hardware installed due to pool

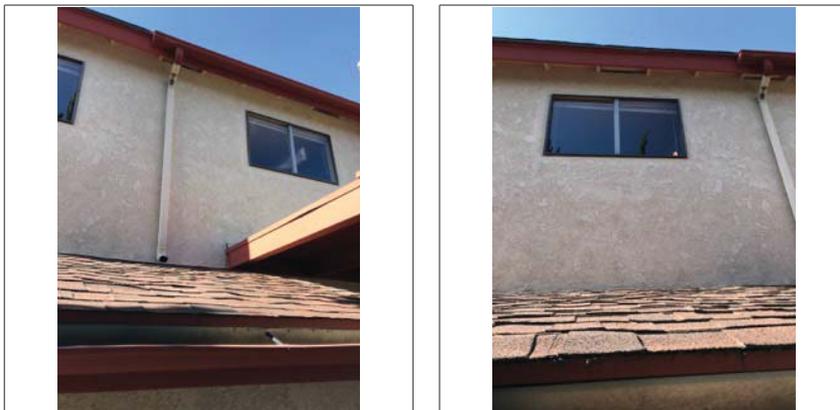
- Condition** Satisfactory Marginal Poor Wood rot Recommend repair/painting
- Recommend repair/replace damaged screens Failed/fogged insulated glass
- Material** Wood Metal Vinyl Aluminum/Vinyl clad
- Screens** Torn Bent Not installed Satisfactory
- Comments** Most upstairs missing screens

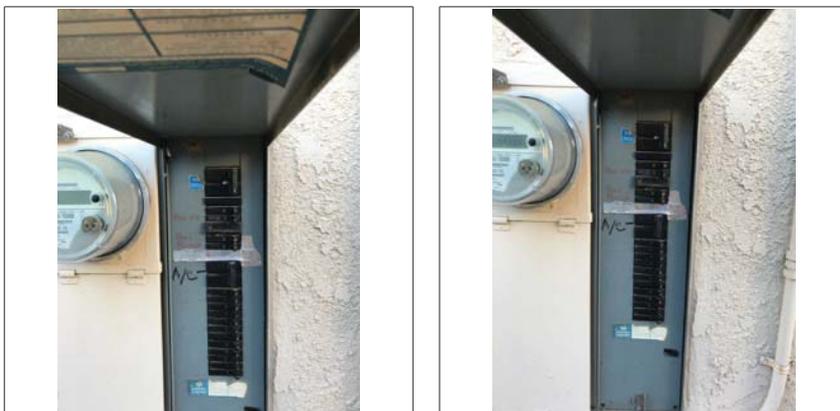
Location Underground Overhead
Condition Satisfactory Marginal Poor Weather head/mast needs repair Overhead wires too low
Exterior receptacles Yes No Operable: Yes No Condition: Satisfactory Marginal Poor
GFCI present Yes No Operable: Yes No Safety Hazard Reverse polarity Open ground(s)
 Recommend GFCI Receptacles
Comments Receptacles attached to home in backyard not operable
Photos

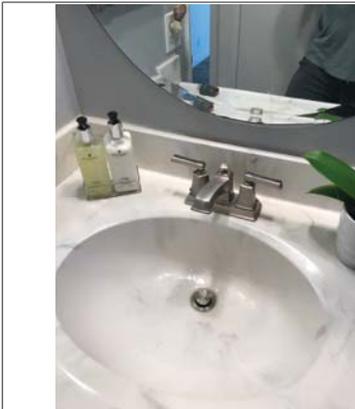
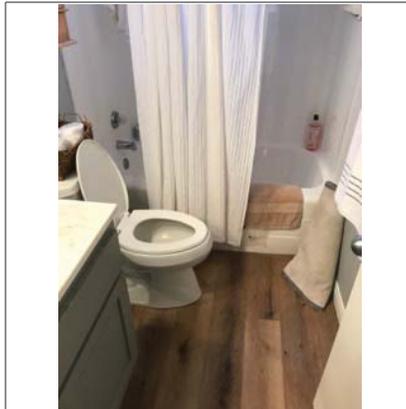
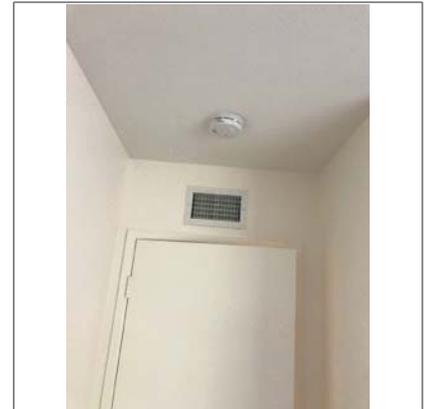
- Heat source present** Yes No
- Exhaust fan** Yes No Operable: Yes No Noisy
- Comments** Hot water side of sink has no flow
- Open ground/Reverse polarity - Copy** Yes No Potential Safety Hazard

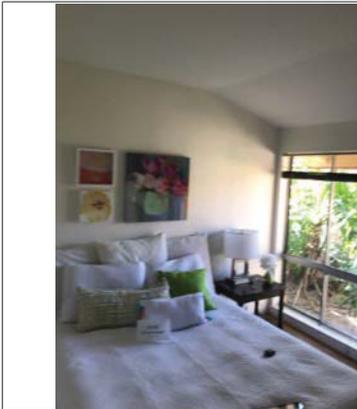
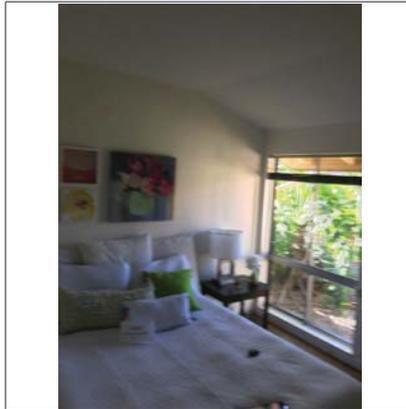
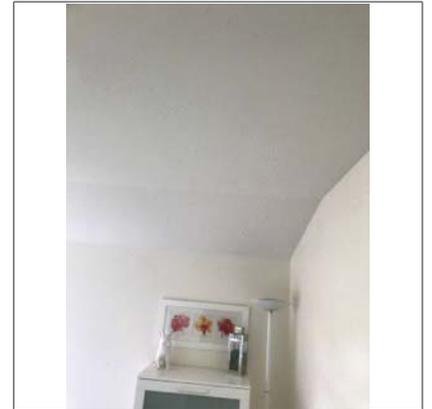
Comments Missing screens
