HOME INSPECTION REPORT

Your Home

Sunday, July 28, 2019

9134

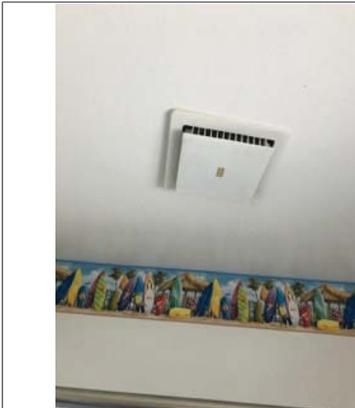
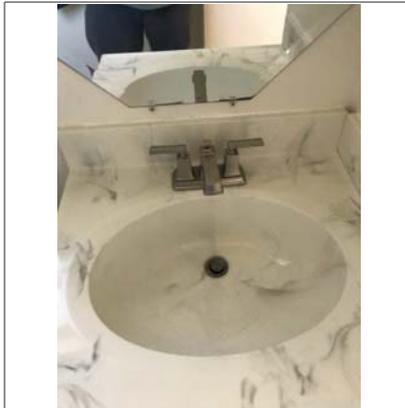
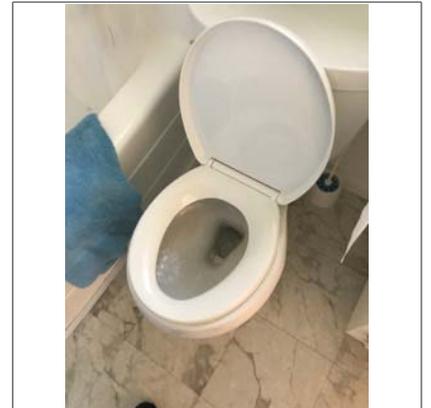
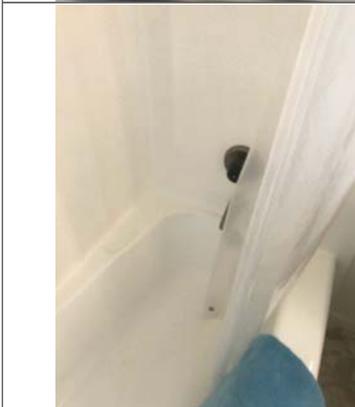
Comments Water not working in shower
 Unable to check drainage in shower
 Exhaust fan inoperable
